Failure modes and reinforcement techniques for timber beams – State of the art

Steffen Franke^{a,*}, Bettina Franke^a, Annette M. Harte^b

- Review of typical materials, cross sections and forms of timber beams.
- Description of general failure modes and their possible causes.
- State of the art of established retrofitting and reinforcement techniques.
- Discussion of case studies for reinforcement techniques.

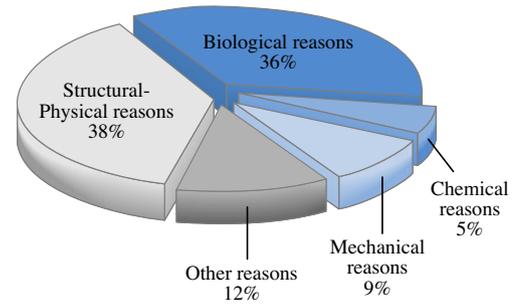
Fig. 1. Reasons for damages, [1,2].

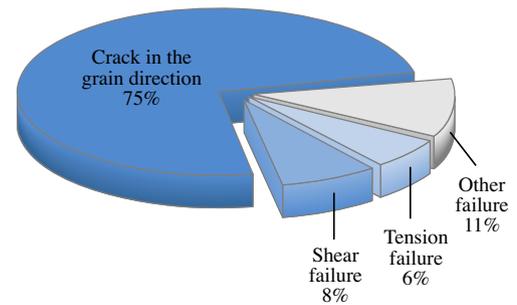
Fig. 2. Types of failure, [1,2].

The most common type of failure, Fig. 2, was observed as the appearance of cracks in grain direction. The variation of the surrounding climate at a timber beam changes the moisture content and lead to shrinkage or swelling of the cross section. Non uniform distributions of the moisture content over the cross section and/or restraint deformations lead to internal stresses and, if the material strength is exceeded, to cracks in the cross section which can significantly reduce the capacity, Figs. 3 and 4. For the determination of the influence of cracks in timber beams on the residual load carrying capacity or stiffness no comprehensive methods are known. Methods and guidelines for this evaluation are currently under development at the Bern University of Applied Sciences.

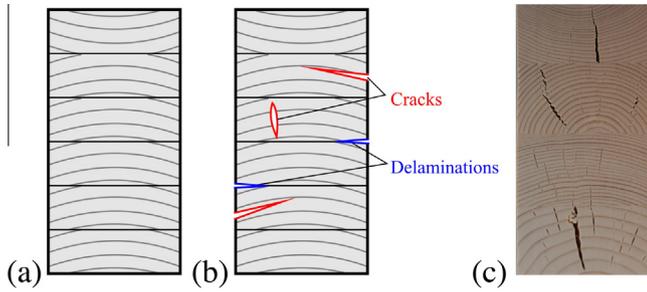
Fig. 3. Glulam cross sections; (a) sketch of undamaged cross section with 100% capacity, (b) sketch of cross section with some possible damage and unknown capacity, (c) real example of cross section with internal cracks.

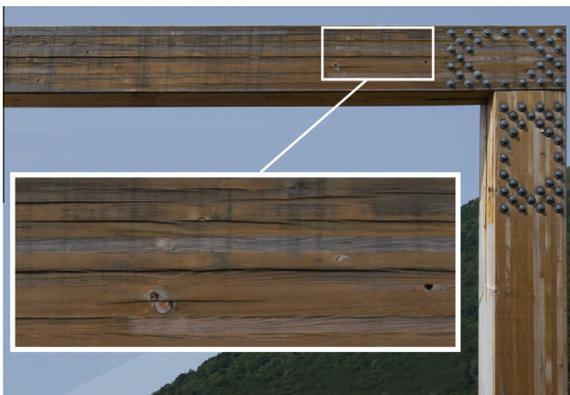
Fig. 4. Cracks in grain direction at a glulam member.

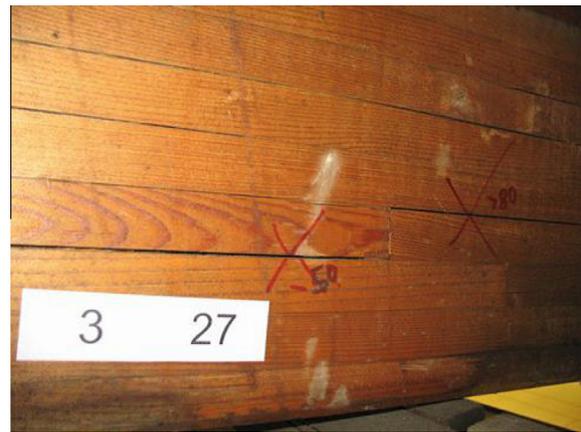
Fig. 5. Delamination at a glulam member.

Note: Failure under tension stress perpendicular to the grain in glulam members has to be distinguished from delamination failure within the glue lines as shown in Fig. 5. Special techniques can be used for the classification of delaminations as shown in [3].

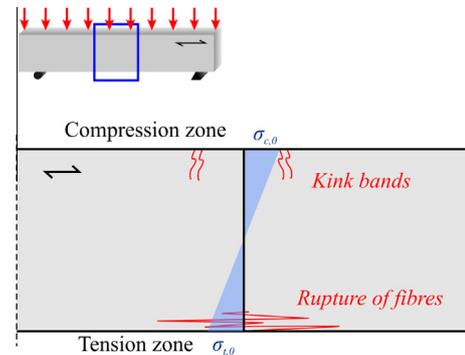
Fig. 6. Principal sketch for bending failure.

Bending results in longitudinal tension and compression stresses distributed over the depth of the cross section. The tension stress leads to a brittle failure due to the rupture of the wood fibres, as shown in Fig. 6. Longitudinal compression stress results in elastic and plastic deformations which can be described as ductile and leads to the so-called kink bands.

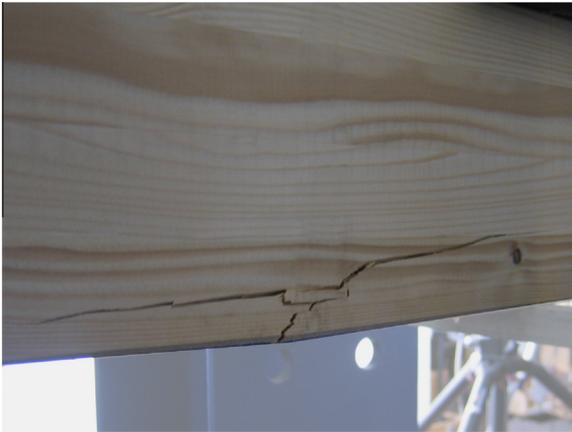
Fig. 7. Tension failure under bending.

Due to natural defects, such as knots, the tension strength can be reduced compared to compression strength. Therefore, bending failure is mainly described by brittle failure of timber beams within the tension zone, as shown in Fig. 7. Bending failure is classified as critical and can lead to a single failure of the structural element or the complete construction.

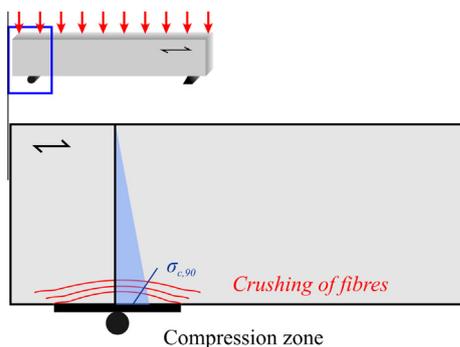
Fig. 8. Principal sketch for compression failure at support.

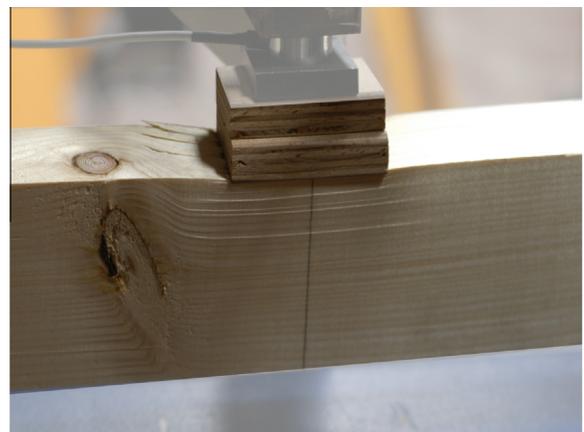
Fig. 9. Compression failure at loading point.

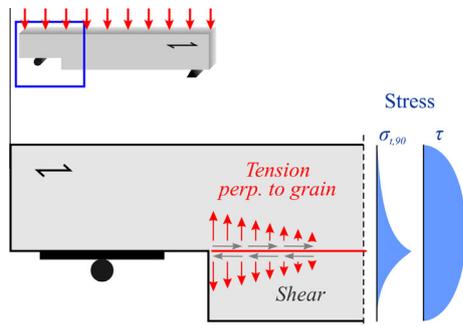
Fig. 10. Principal sketch for tension failure perpendicular to the grain at a notch.

Tension stress has to be considered parallel to the grain and perpendicular to the grain directions. When the tensile capacity of the timber is exceeded, brittle failure occurs. Examples of tensile failure parallel to the grain and perpendicular to the grain are shown in Figs. 10–12. However, due to the low tension strength perpendicular to the grain of wood, which is almost zero due to natural defects, failure under tension stress perpendicular to the grain occurs more often. Therefore, wood products are mostly optimised to increase the tension strength perpendicular to the grain. However tension stresses perpendicular to grain has carefully to be considered in the design. Tension stress perpendicular to the grain occurs in curved, tapered and end-notched glulam members as

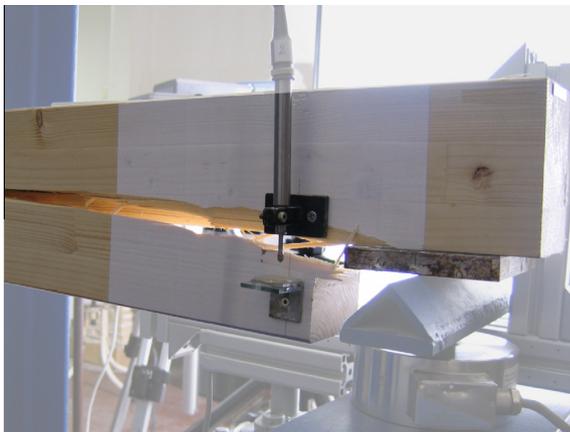
Fig. 11. Tension failure perpendicular to the grain at a notch.

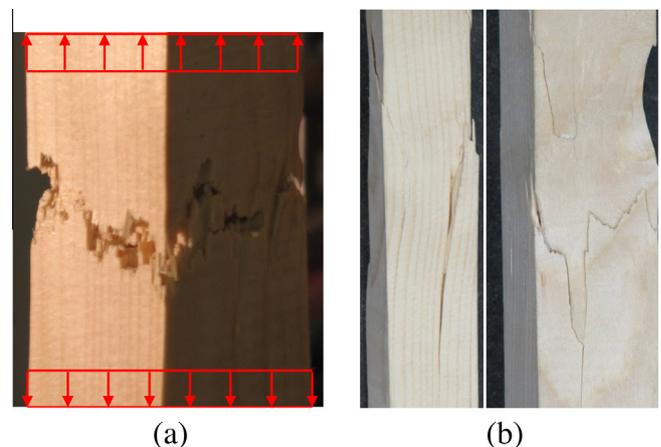
Fig. 12. Tension failure parallel to the grain of experimental tension tests: (a) short-fibred, (b) long-fibred, [4].

For the case of notched end beams, the stress concentration at the corner of the notch leads to crack initiation and rapid crack propagation results in a sudden brittle failure of the beam as shown in Fig. 12. The high tensile stresses perpendicular to the grain are accompanied by high shear stresses. Different reinforcement methods are illustrated in Fig. 24. The reinforcement can be deployed perpendicular to or at 45° to the beam axis. Due to the presence of high shear stresses, the performance of notched beams reinforced at 45° is superior. This has been validated by a number of experimental investigations [39–42]. Reinforced

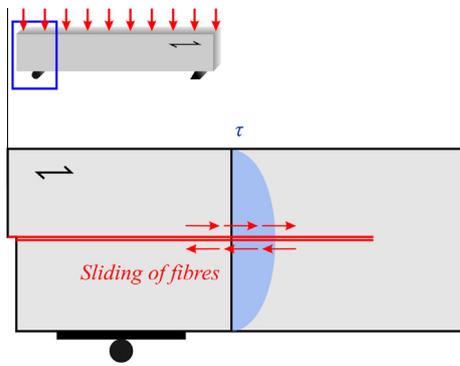
Fig. 13. Principal sketch for shear failure.

In most cases, bending stress and deflection limits govern the design of the members. But for short beams, tapered beams or special loading situations the shear stress can be more important. In general for beams, the shear stress reaches the maximum value close to the supports (Fig. 13). Additionally, end-notched beams and beams with holes can lead to shear stress concentrations, [5,6]. Failure due to shear stress is characterised by a sliding of the fibres and thus cracking parallel to the grain and is considered as a brittle failure. The cracks are mainly closed and therefore hard to detect if they are not at the end of the beam, as shown in Fig. 14.

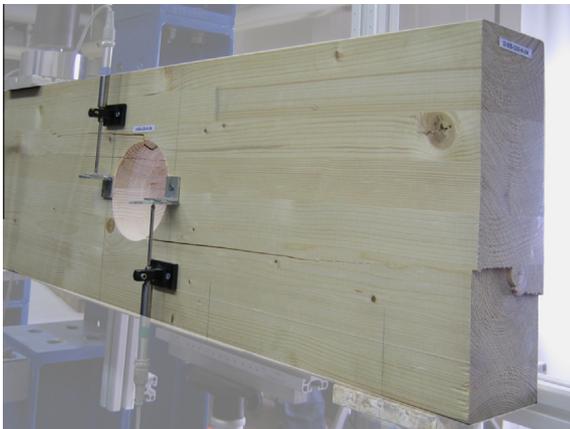
Fig. 14. Shear failure at holes.

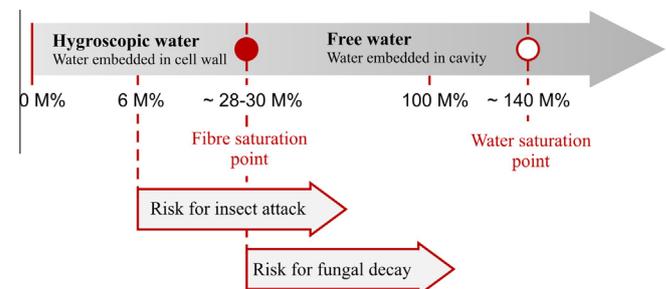
Fig. 15. Risk of insect and fungal decay in relation of the moisture content.

Decay due to fungi is possible for timber beams with a moisture content close to/or over the fibre saturation point, see Fig. 15. The fibre saturation point varies from wood to wood species and shows a range from 26–32 M% (in mass percentage). The different fungi and their typical appearance and hazard are summarized in [7].

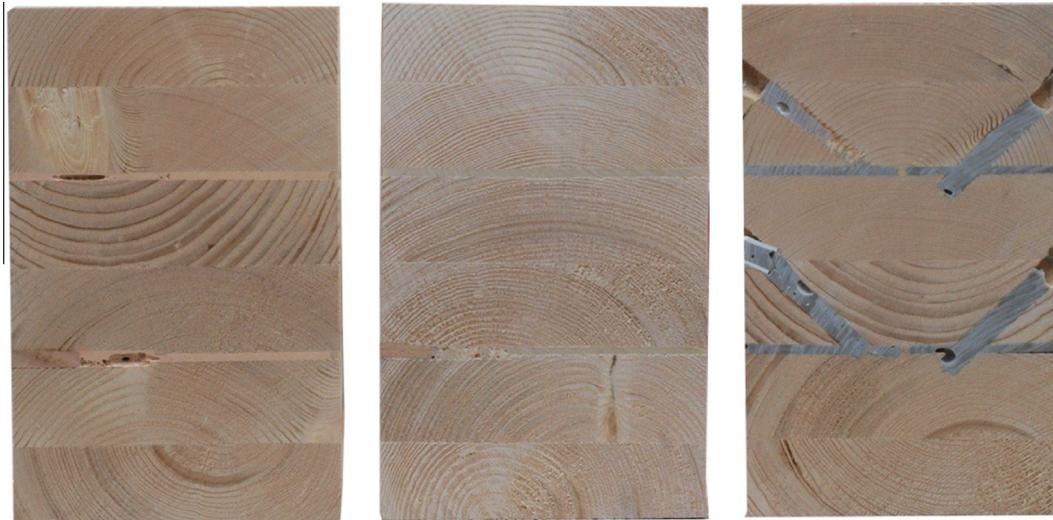
Fig. 16. Result of different repair methods (pouring and injection) for different adhesives, CSA Resin n'H Lungern (left), Purbond RE 3040, RE 3064 (middle), Jowat 692.30 (right), [13].

To ensure adequate load carrying capacity, the preparation of the bonding surfaces is important to ensure the required quality of the applied technology and to avoid defects. In general, the repair procedure involves cutting out the cracks using a saw, router or grinder to make a clean slot. Before filling with a suitable adhesive, the slot has to be cleaned, optionally brushed with a primer and filling- and ventilation holes have to be prepared. Optional supporting systems for the member may have to be used. Fig. 16 shows the results of applying different technologies for repairing cracks or delamination depending on corresponding adhesives.

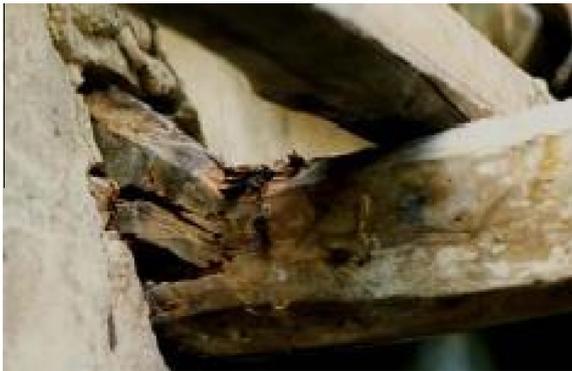
Fig. 17. Beam end decay [15].

Timber that has decayed due to fungal or insect attack is porous, fragile and has very poor strength properties [14]. This decay often occurs in localised parts of the beam, such as at the ends where the timber is in direct contact with a masonry supporting wall as seen in Fig. 17. In these cases, the condition of the rest of the beam is generally good. Other types of accidental damage, such as fire damage, may cause a reduction in the member cross-section resulting in inadequate strength and stiffness. Decayed and damaged materials/products should be removed and the member upgraded to restore the load-bearing capacity of the member.

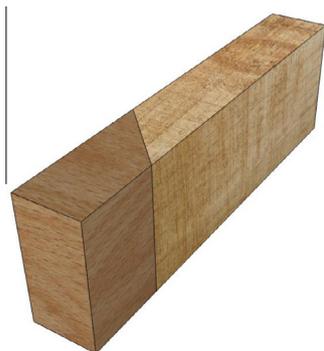
Fig. 18. Prosthesis with scarf connection.

Repair methods include replacing the damaged section with a timber or engineered wood prosthesis connected to the original beam by means of a scarf joint with wooden pegs and/or adhesive (Fig. 18), by means of bonded-in rods or plates (Fig. 19), [16].

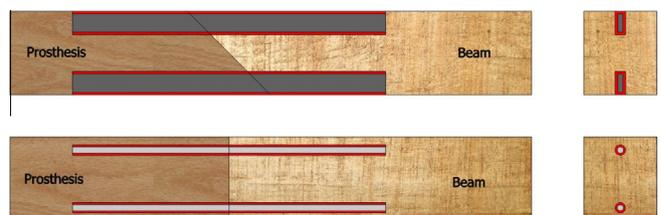
Fig. 19. Beam end repair using bonded in rods or plates.

The most common retrofit method employed involves replacing the damaged timber with a timber prosthesis which is bonded to the sound timber in the original beam using steel or fibre reinforced polymer (FRP) rods or plates. Using this approach, the scale of the intervention is limited and the load bearing function is preserved. The implementation of this type of repair involves a number of different steps [17]. Initially, the beams are propped. The damaged part of the beam is then removed by cutting either vertically or at an angle of 45° to the vertical, as seen in Fig. 19. Holes or grooves to take the connecting rods/plates are drilled in the beam and the prosthesis and are partially filled with adhesive. The reinforcing elements are inserted into the beam and prosthesis and the adhesive is topped up in holes/grooves if necessary. Additional props are introduced to support the prosthesis. When grooves are used, a timber strip is normally inserted to improve the

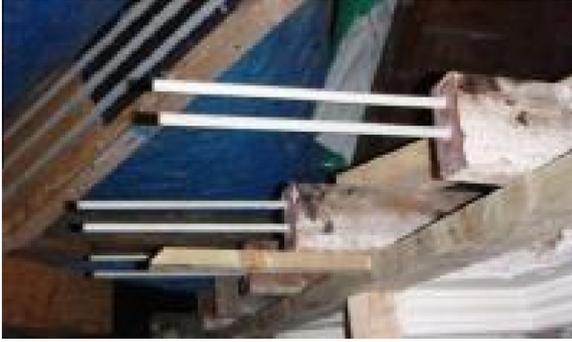
Fig. 20. GFRP rods inserted in ends of propped beams [18].

The span beams were repaired using an LVL prosthesis that was attached to the beams using six 20 mm diameter steel rods. The rods were bonded into holes drilled into the end grain of the beams and into matching side slots in the prosthesis, as shown in Fig. 29. Due to the lighter loading carried by the ceiling joists, it was sufficient to use a C24 softwood timber prosthesis that was bonded to the joists using two 12 mm GFRP rods. Fig. 20 shows the rods inserted in the joists before adding the prosthesis.

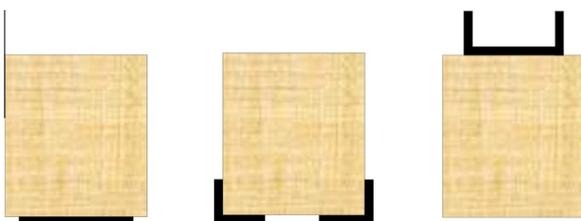
Fig. 21. External reinforcement arrangements.

Failure in tension perpendicular to the grain in timber beams can arise in notched beams, around holes and in curved, tapered or pitched cambered beams. Reinforcement of beams in these situations can be achieved using internal or external reinforcement. Types of internal reinforcement include self-tapping screws, bonded-in or drilled-in threaded steel rods or bonded-in FRP rods or tubes. External reinforcement is achieved by mechanically fixing and/or gluing on sheets of wood-based panels, such as plywood, or FRP sheets or nail plates.

For screws or glued-in rods, the requirements for minimum edge distances and spacing must be satisfied while keeping the reinforcement as close as possible to the notch corner [9,10]. Externally bonded sheets of FRP or plywood are placed on both sides of the beam and extend over the full height. Screws are normally used to provide the required bonding pressure while the adhesive is curing.

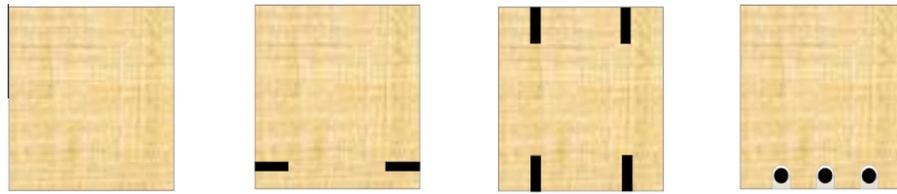
Fig. 22. Internal reinforcement arrangements.

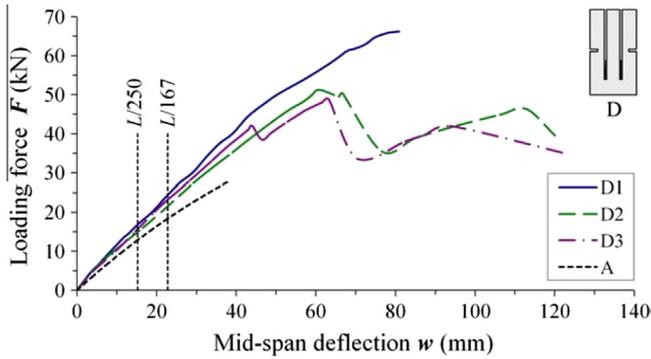
Fig. 23. Load–deflection response of unreinforced (A) and reinforced (D1, D2, D3) beams, [19].

As timber beams generally fail in tension in a brittle fashion, positioning of the reinforcement on the tensile face of the beams is very effective for increasing bending strength. With increasing percentage of tensile reinforcement, the neutral axis of the beam moves towards the bottom of the beam. As a result the compressive strain in the timber increases relative to the tensile strain and compressive yielding may occur before the timber eventually fails in tension. The load–deflection response for a timber beam reinforced with carbon fibre reinforced polymer (CFRP) plates, which were inserted from the top, is shown in Fig. 23, [19]. The unreinforced beam A has a brittle response. For the reinforced beams, two of the beams display significant ductility in their response before failure.

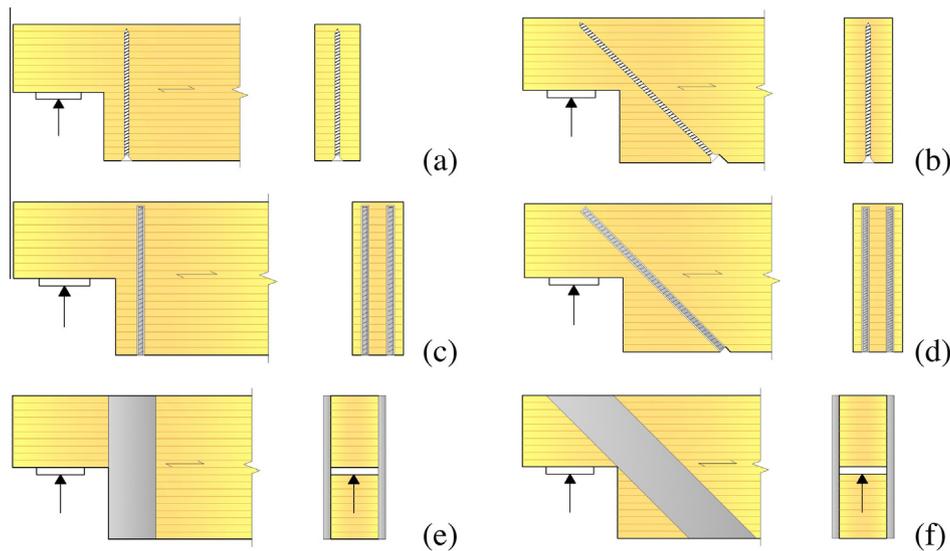
Fig. 24. Typical reinforcement arrangements for notches. (a) & (b) self-tapping screws, (c) & (d) glued-in rods, (e) & (f) EWP or FRP side plates.

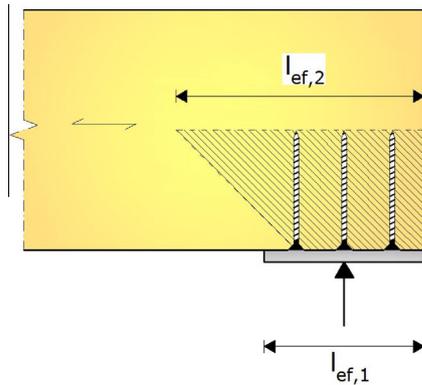
Fig. 27. Reinforcement for compression perpendicular to the grain.

where n is the number of screws, R_d is the lesser of the withdrawal capacity and the buckling capacity of the screw, $f_{c,90,d}$ is the design value of the compressive strength perpendicular to the grain [47], b is the beam width, $l_{ef,1}$ and $l_{ef,2}$ are the lengths as defined in Fig. 27, and $k_{c,90}$ is a load distribution coefficient in the range [1;1.75]

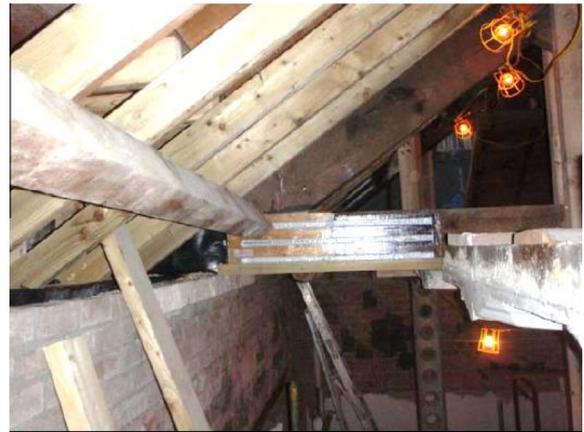
Fig. 29. Span beam repair [18].

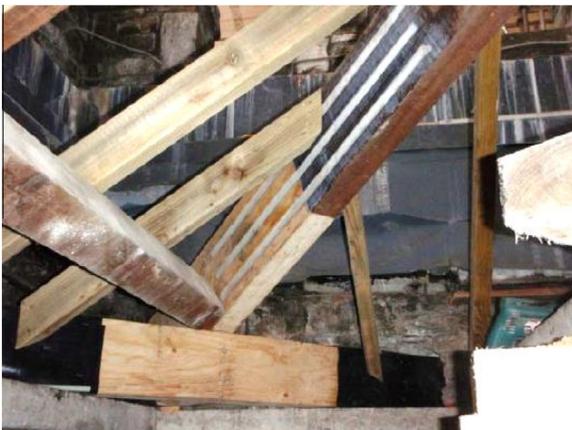
Fig. 28. Hip rafter repair [18].

An upgrade procedure was required that did not interfere with the ornate suspended ceiling. The solution that was adopted was to replace the decayed timber in-situ with a prosthesis made from laminated veneer lumber (LVL). Due to the restriction on access, the connection between the prosthesis and the hip rafters was effected using slots routed in the sides of the prosthesis and the rafter into which six 16 mm diameter high tensile steel rods were bonded using a two-part epoxy structural adhesive. Fig. 28 shows the prosthesis in place with the rods inserted in the slots prior to topping up with adhesive.

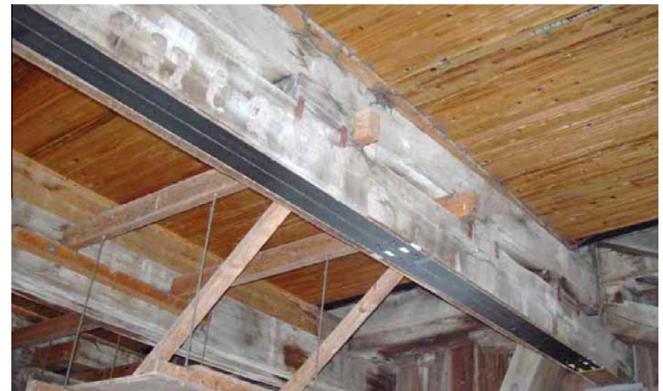
Fig. 30. Long-term monitoring of Sins Bridge, [57].

The cross-beams comprised two solid oak beams placed one on top of the other. The 1 mm thick CFRP laminates were bonded to the top and bottom surfaces using epoxy resin. Two types of CFRP were used: One was a high modulus material ($E = 305$ GPa, tensile strength = 2300 MPa) and the other was a high strength material ($E = 152$ GPa, tensile strength = 2600 MPa).

The reinforced cross-beams and a number of unreinforced crossbeams were instrumented with electrical resistance strain gauges and Demec gauges in order to monitor their long-term performance (Fig. 30). The deflection of the reinforced cross-beams was 20–50% lower than the unreinforced beams. Fourteen years after the original installation, the performance of the reinforced beams continued to be satisfactory [56].
